Ligament Balancing in Severe Osteoarthritis Knee with Large Cyst and Bursae - A Rare Case Report with Review of Literature

INTRODUCTION

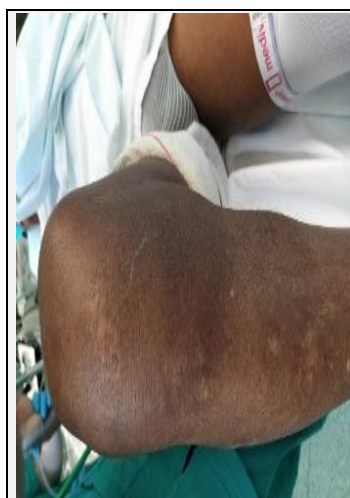
Figure 1.
On Clinical Examination, the Patient Had Varus Deformity with Swelling on the Medial Side of the Knee

A 61-year-old male with severe O / A right knee was admitted to Cascais hospital, Lisbon for right side TKR. On examination, the patient had varus deformity with swelling on the medial side of the knee (Figure 1, 2). The range of motion (ROM) was 10 to 100. For swelling patient underwent ultrasonography (USG) of the medial side of the knee that showed cyst under medial collateral ligament (MCL). Magnetic resonance imaging (MRI) confirmed cyst of size 4 x 3 cm under MCL (Figure 3, 4). Scanogram shows varus of almost 8 degrees with lateral subluxation of the tibia (Figure 5).

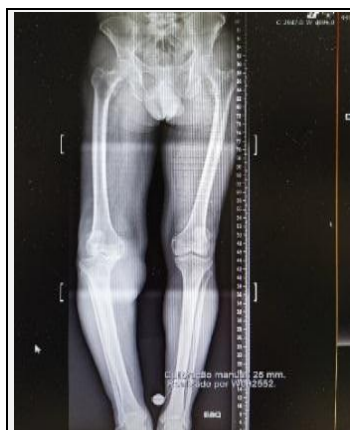
Figure 2.
On Scanogram Examination, the Patient Had Varus Deformity with Swelling on the Medial Side of the Knee

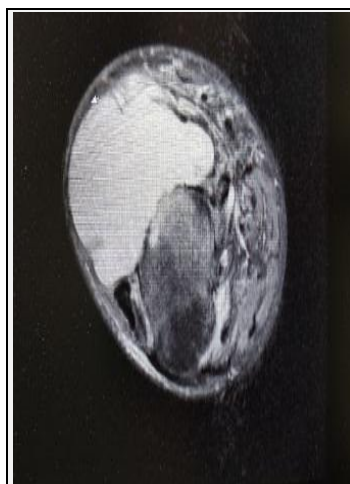
Figure 3.
MRI Showing Large Cyst under MCL

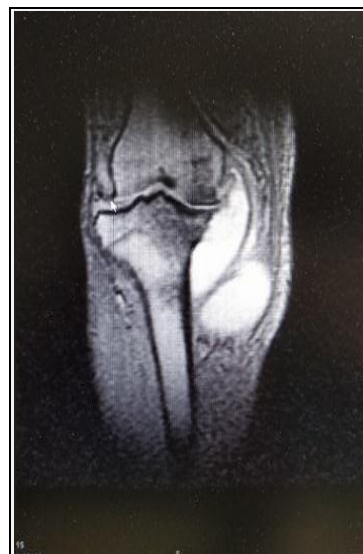
Figure 4.
MRI Showing Large Cyst under MCL

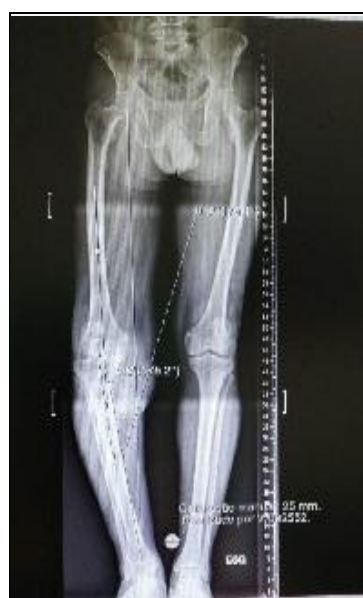
Figure 5.
Scanogram Shows Varus of Almost 8 Degrees with Lateral Subluxation of the Tibia

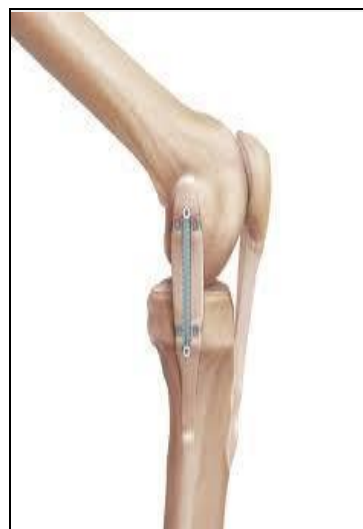
Figure 6.
Preoperatively Internal Brace (Arthrex) was Kept

During preoperative planning, internal brace (ARTHREX) (Figure 6) and constrained knee were kept for back up to handle MCL laxity after cyst removal.

Operation was done through a midline incision and medial parapatellar approach. Cyst got drained spontaneously during exposure. Minimal release on the medial side was done. Standard bone cuts were taken as per the preoperative template (sigma j & j). But during extension lateral gap was big than the medial side. Even after using the largest size insert, lateral laxity was there. The internal brace was used from Arthrex to augment the lateral collateral ligament. His knee was stable after surgery.
