CASE REPORT

ACCIDENTAL DEATHS DUE TO ELECTROCUTION DURING AMATEUR ELECTRO-FISHING

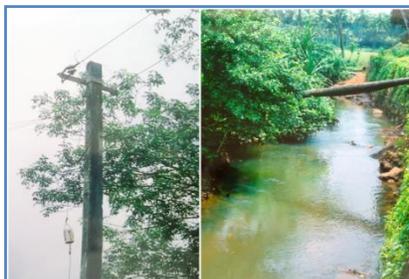
Figure 1: The overhead electric line from which the electricity was diverted is seen on the left. The nearby stream where the deceased was electrocuted is seen on the right. The wire was dropped down near the coconut tree trunk and the deceased was standing downstream.

Case 1: A 29 year old male was fatally electrocuted while fishing using electricity diverted from an overhead electric line meant for domestic supply. Investigation revealed that a group of 6 people were involved in the illegal activity. The contraption used for sourcing electricity was a metal hook attached to the dry stalk of a palm frond. They had attached one end of a 77 meter long wire to the metal hook before it was dangled from the electric line. This part did not result in electrocution probably because the dry palm frond stalk had negligible conducting capacity. The person who dangled the line had climbed the concrete electric post (Fig. 1) to do it.

The electric wire was made up of five smaller wires and the joints were covered with insulating tape. After one end of the electric wire was dangled from the post, they dropped the other end into the small stream (Fig. 1) nearby. The deceased had climbed down into the water downstream where the depth was knee deep to pick up fish with his bare hands. He suddenly fell down and suspecting that he was electrocuted, the others disconnected the wire and picked him up.

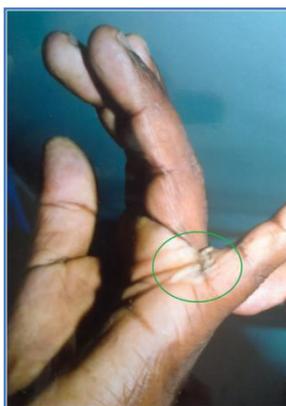
Figure 2: The electric burn mark at the root of left little finger. The adjacent part of palm is also involved.

On autopsy, a contact electric burn mark (measuring 1.5 X 0.5 cm) involving the front of left little finger and adjacent part of palm was seen (Fig 2). The only other recent injury on the body was abrasion on the lateral aspect of right foot. This case which happened in 2005 can be taken as an archetype. All the other cases follow the same pattern with minor variations.
